**A NOVEL FRAMEWORK FOR THE ANALYSIS OF LOW FACTOR OF
SAFETY SLOPES IN THE HIGHLY PLASTIC CLAYS OF THE
CANADIAN PRAIRIES**

For the Degree of Master of Science

In the Department of Civil and Geological Engineering

University of Saskatchewan

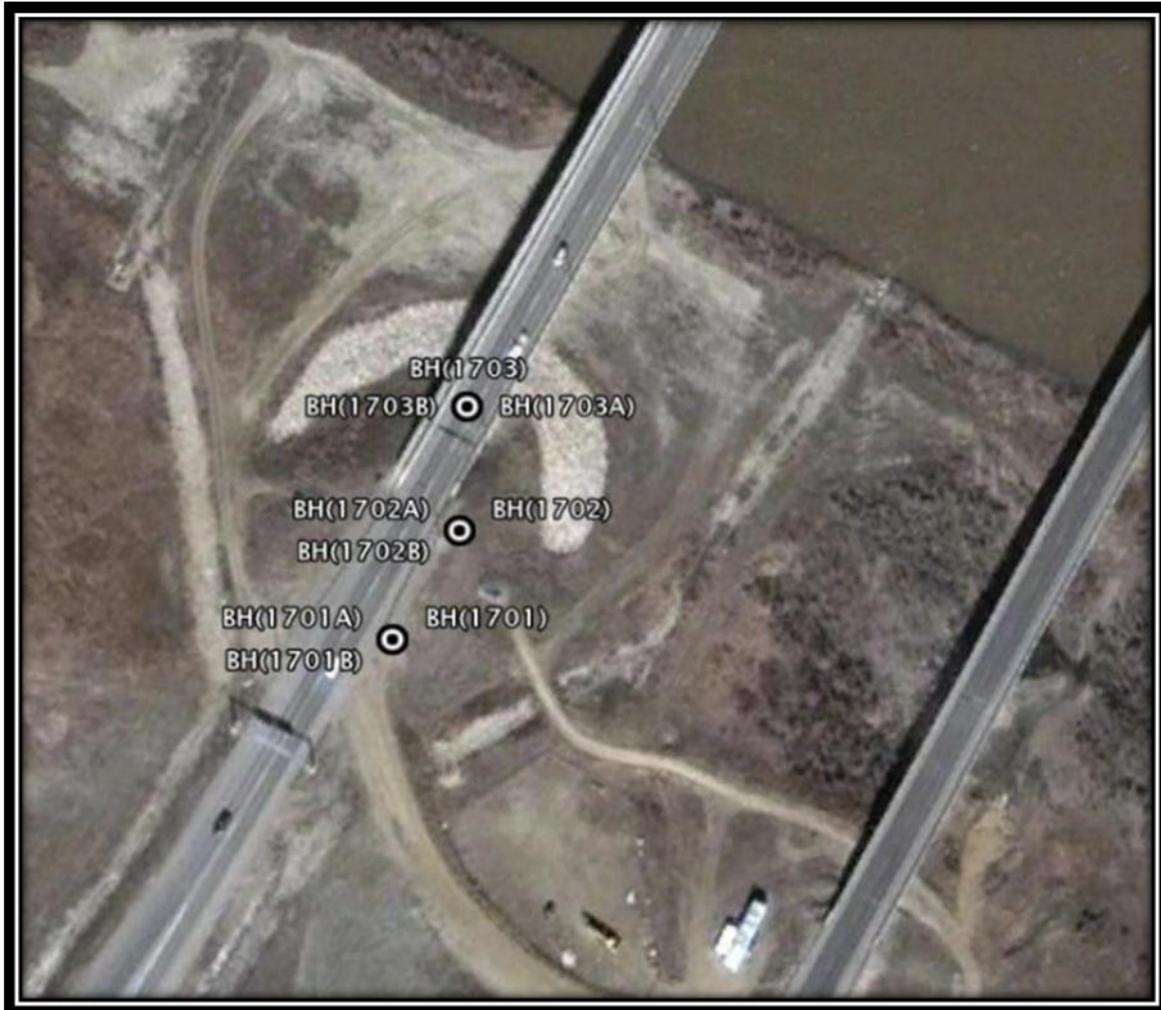
Figure 3.4: 1700 series piezometer locations - Google Earth photo with locations overlain taken from SMHI Geohazards Risk Management Program

Table 3.2: 1700 series piezometers in the new bridge south abutment

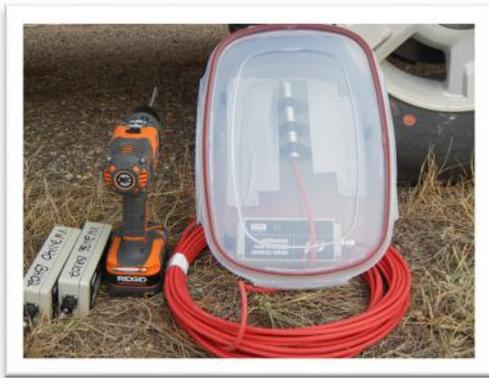
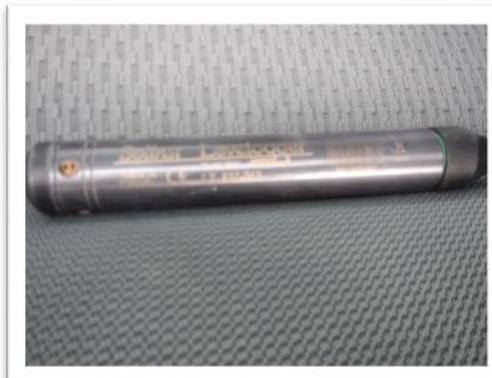
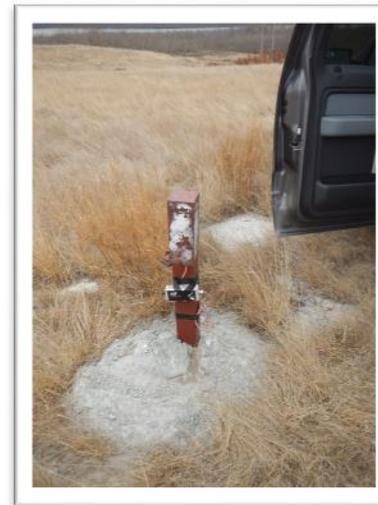
Vibrating wire sensors and data loggers were manufactured by RST Instruments Inc. The vibrating wire sensors were Model # VW2100 and the data loggers were Model # DT2011B. A 5 m level logger was used to record the barometric pressure at the ground surface. Figure 4.10 presents photographs of the equipment used in the collection of data.

Figure 4.10: Photographs of the equipment used for barometric response testing
